Manhole Inspection Summary

Manhole # S45GG_029MH

Record Plat: **45GG** Node: **029** Status: **Found**

Location Address: **Hoffman**

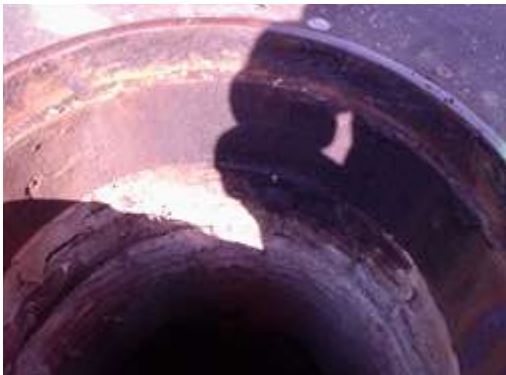
Defect 1

Condition: ☐ Sound ☐ Cracked ☐ Root Intrusion ☒ **Loose Brick** ☐ Deteriorated

Infiltration: ☐ None ☐ Joint ☐ Cracks ☒ **Mortar** ☐ Roots ☒ **Wall**

adjustment joint

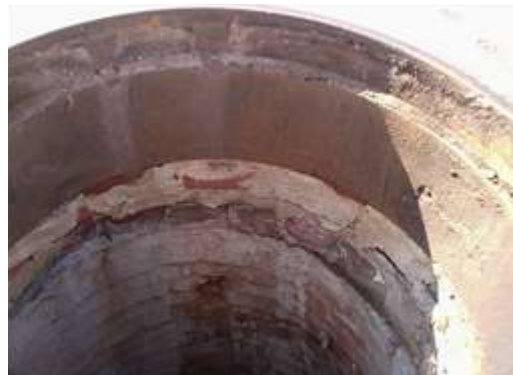
Defect 2

Frame Offset: **1** (in.) Condition: ☐ Sound ☐ Cracked ☒ **Leaks**

frame leaks

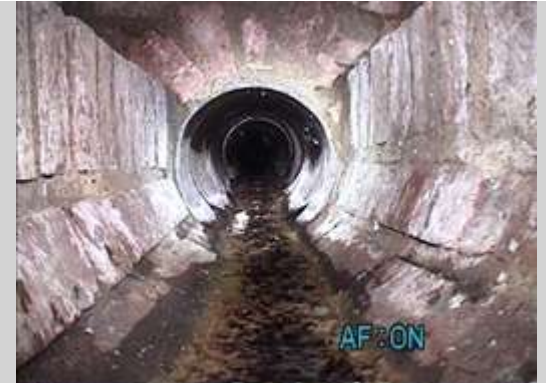
12 O'Clock Outflow

8 in. Circular Gravity Sewer
Pipe Out @ 12 O'Clock

Pipe Height: **8.4** (in.) Rod and Bar (Angled)
Pipe Material: **Clay** ☐ Pipe Lined
Invert Depth: **9.90** (ft.) Flow Characteristics: **Fast**
Deposits: ☒ None ☐ **Mud** ☐ Sludge ☐ **Debris** ☐ Grease
Silt Depth: (in.) Deposits Extent:
Infiltration: **None** Pipe Seal Cond: **Sound**

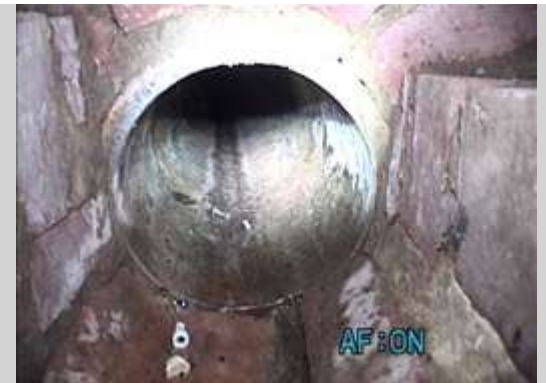
4 O'Clock Inflow

6 in. Circular Gravity Sewer
Pipe In @ 4 O'Clock

Pipe Height: **6** (in.) Rod and Bar (Angled)
Pipe Material: **Clay** ☐ Pipe Lined
Invert Depth: **9.40** (ft.) Flow Characteristics: **Slow**
Deposits: ☒ None ☐ **Mud** ☐ Sludge ☐ **Debris** ☐ Grease
Silt Depth: (in.) Deposits Extent:
Infiltration: **None** Pipe Seal Cond: **Sound**

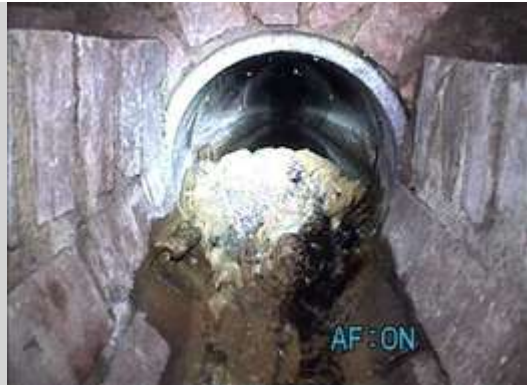
6 O'Clock Inflow

Deposits: ☐ None ☒ **Mud** ☐ Sludge ☒ **Debris** ☐ Grease

Silt Depth: **4** (in.) Deposits Extent: **Medium**
